# BUILDING ANALYSTS

# WHY SOME BALCONIES FAIL

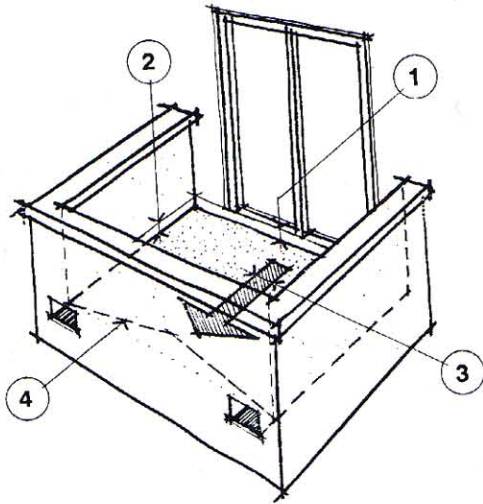
## 1 Not Enough Vertical Offset at the Door Threshold

A 1-1/2 inch vertical separation between the interior and exterior surface is recommended:

- To avoid wind-driven water from getting inside.
- To provide a vertical surface to attach the waterproof membrane.
- To provide continuous "Z"-metal flashing.

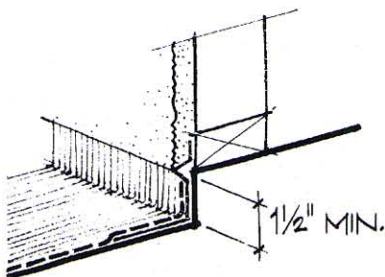
## 2 No Waterproofing on the Sides of the Balcony

- The waterproof membrane should be extended up the vertical surface about 1-1/2 inches to create a continuous waterproof membrane along the balcony sides.
