THE DEMON WOOD ROT

BUILDING ANALYSTS

SPRING 1992 NEXT ISSUE : ROOF FLASHING

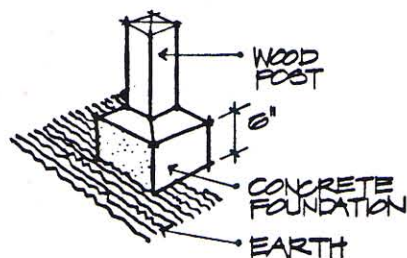
2 Finish Grade Too Close to Wood Structures

• Uniform Building Code, Section 2516(c)7, requires a six-inch minimum separation between finish grade and wood structures. Less separation poses a potential termite as well as wood rot problem.

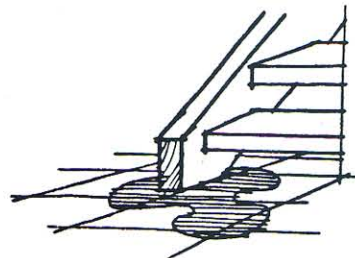
3 Wood Stair Stringer Deterioration

• Untreated Douglas fir is commonly used for stair stringers that are placed directly on a concrete slab, and often this practice develops wood rot if exposed to moisture. The Uniform Building Code, Section 2516(c)7, requires a decay-resistant, or pressure-treated, wood for stair stringers placed on a concrete slab on grade.

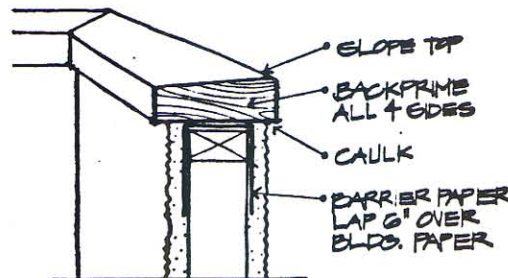
4 Wood Balcony Railings Often Leak into the Building Frame

Railings often split and warp, generally offering little protection for the wall below.

• An additional layer of barrier paper, or a product such as "Jiffy Seal," should be installed over the standard building paper at the top of the wall. The barrier paper should lap down six inches on each side over the building paper.

• Slope the top railing member to alleviate standing water.

• All railing and trim members should be painted on all sides to reduce warpage and splits in the wood, including fresh end cuts.

• Caulking and flashing should be used at intersections to prevent water entry.
